# Explosion Risk Reduction (Construction Additives)

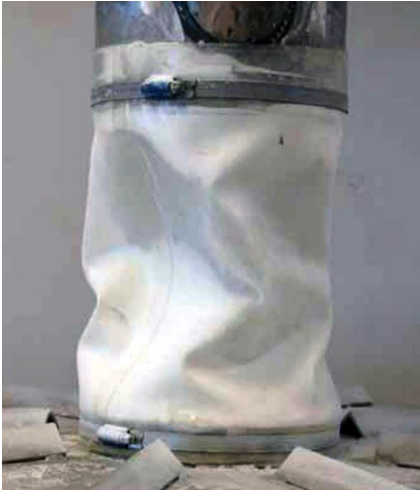
BEFORE

Fine, abrasive powders, combined with a pneumatic conveying system, meant that even small tears or gaps in the traditional clamped flexible connectors at the plant caused dust leakage.

The hose-clamp seals did not perform well under pressure, and with 25 different fittings, manual error with installing the existing clamp & hose connectors to the incorrect length also added to the leakage problems.

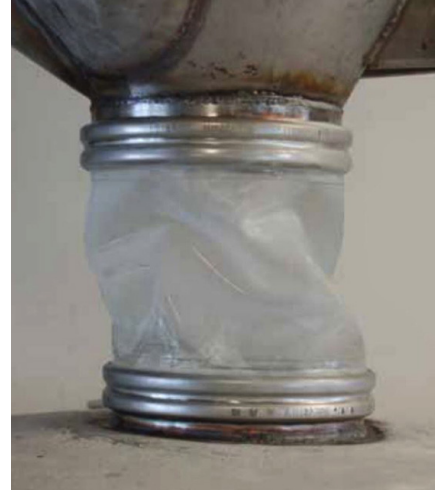
AFTER

After an initial trial BFM® fitting system was installed in the most challenging position on the sifter, the seal was so superior that AkzoNobel are now replacing all 25 flexible connectors with BFM® fitting. There is no longer dust leaking into the plant, and this has significantly reduced the risk of explosion.

**EXPLOSION:** The sealed system created by the BFM® fitting has removed the dust leakage in the air, significantly reducing the risk of explosion.
