FOOD

Hygiene (Dairy)

A leading New Zealand dairy plant had a major challenge with hygiene in their blending filler room. A vibratory discharging cone was connected to the hopper via a traditional connecting sock and steel clamps. There was excessive dust leakage and product build-up in the joins - a major hygiene issue. Since installing the BFM® fitting system, the room is clean and there has been a significant reduction in both downtime and replacement costs.

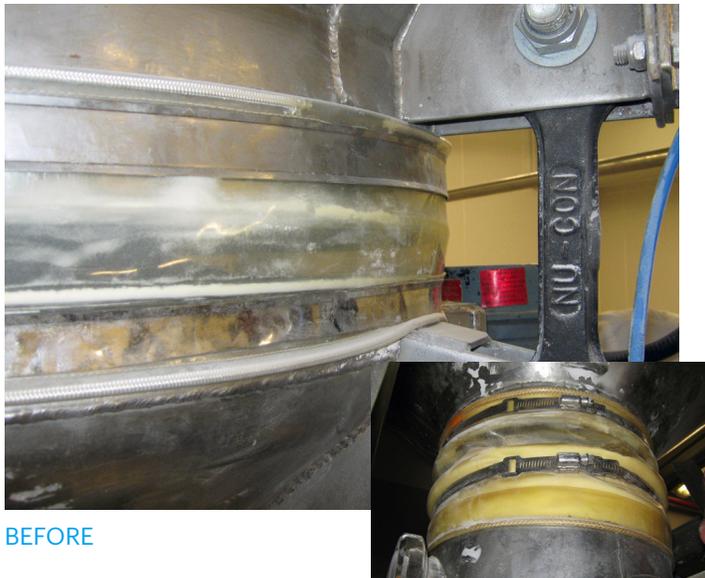
BEFORE

The regular gas purging of the system forced powder through small gaps in the old-style sock and steel clamp connector. This caused an unhygienic environment and hours of down-time for regular cleaning. There was also a major contamination point created by significant product build up between the externally fitted sock and hopper.

The steel strapping clamps were very time consuming to remove and re-fit during sock cleaning & replacement.

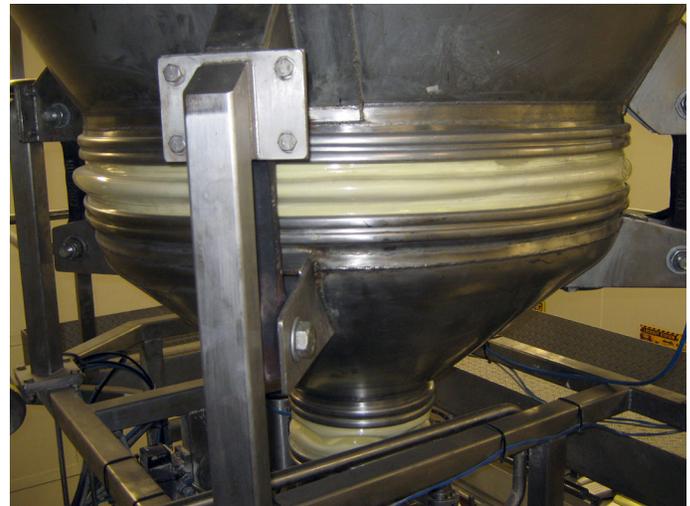
AFTER

The installation of a BFM® fitting for both the upper and lower connections has created a sealed system, and the filling room is now a dust-free environment. The pressure from the gas purging no longer causes product leakage, and because the fitting sits inside the spigot, there is no product build-up at the connector joins.

When the fittings do need replacing, it's now a quick and easy snap-fit process.
